(21) 14 pages  
OPERATION CASTLE

Project 3/5 [07]

(8)  
BLAST EFFECTS ON MISCELLANEOUS STRUCTURES

REPORT TO THE SCIENTIFIC DIRECTOR

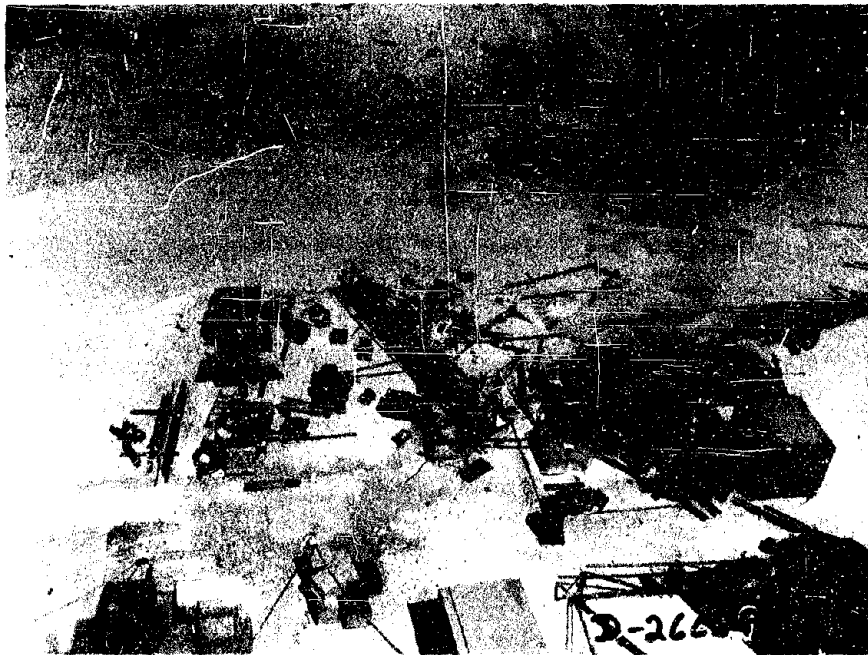
Fig. 3.3 Postshot Tent Damage in Scientific Area, Tare Island  
14-3/4 Miles from GZ

The type of damage inflicted to the tents on Tare Island can be described in four general categories. The first type of damage which is of interest occurred in the living area where the sides of the eight-man tents were oriented about 62 degrees from the direction of burst as shown in Fig. 2.1. Generally, the first two rows of tents in each block were moved bodily from their slabs. This type of damage is best illustrated by referring to Figs. 3.1 - 3.5.

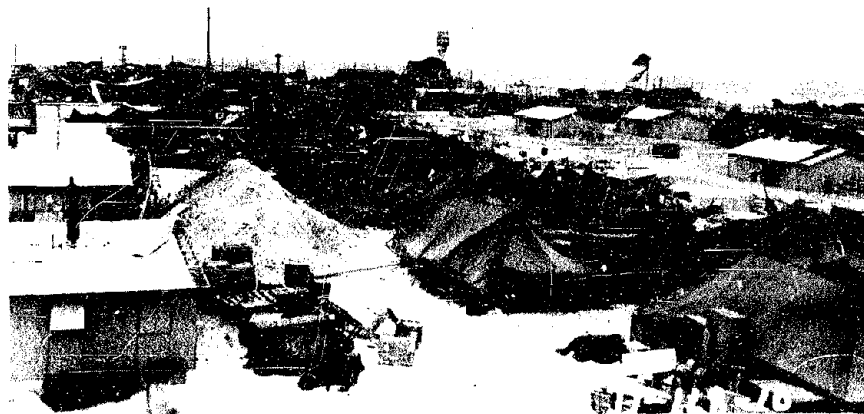
Fig. 3.5 Camp and Warehouse Area, Tare Island Postshot, 14-3/4 Miles from GZ

The second type of damage also occurred to eight-man tents, this type of damage consisted of failure of the two 2" x 6" hip rafters on the end or side of the tent most nearly facing ground zero; the end result being a partial or complete collapse of the tent roof. This type of damage can be observed in Figs. 3.1, 3.2, 3.5, and 3.6.

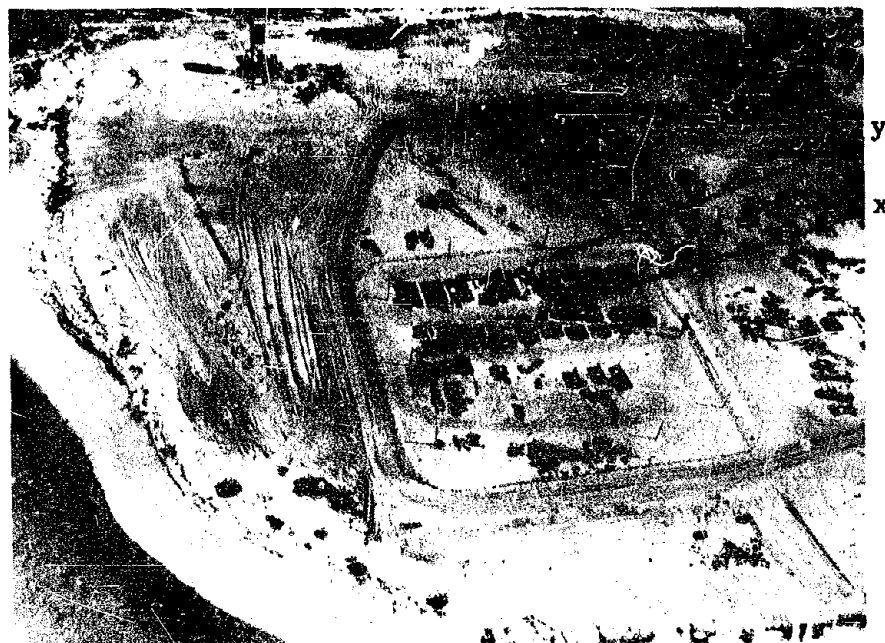
Fig. 3.6 Technical and Scientific Areas, Tare Island, Postshot, 14-3/4 Miles from GZ

The fourth type of tent damage was fire in the technical area. It will be noted that a fire was started in the tent marked X (Origin I) in Fig. 3.6 and spread downwind (Figs. 3.8 - 3.10) finally engulfing a Signal Corps trailer. A similar fire (Fig. 3.11) started in the tent marked Y (Origin II) in Fig. 3.6 but did not spread. The initial fires

were caused by electrical shorts at the master switch control panels, the power having been left on during the shot. There was no evidence of damage due to primary thermal radiation. The reasons for the fire spreading from its origin can be fairly well established. First, the fire spread downwind. The surface winds were brisk and fairly constant in direction. Second, all the tents except one downwind of fire origin had gasoline stored in them. Also, some tents had paint, polyethylene, and other inflammables stored inside. Two of the tents contained portable gasoline-driven generators. The tent immediately downwind of the fire origin had six 5-gallon and two 1-gallon gasoline containers. The next tent downwind had a number of polyethylene bottles in storage.

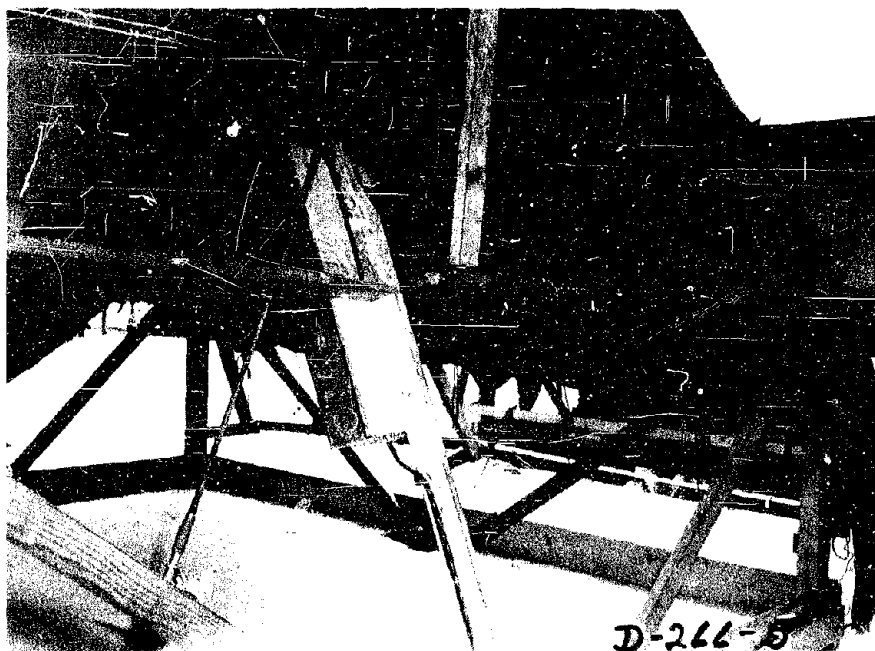
Fig. 3.7. Typical Damage to Four-man Tents, Tare Island, Postshot,  
14-3/4 Miles from GZ

The third type of damage was the failure of the 2" x 4" top plate (see Fig. 3.7) in the ends of the four-man tents which faced nearly into the blast. Most of the four-man tents and some of the eight-man tents suffered this type of damage in varying degrees of severity. Few tent roofs collapsed because of this type failure.

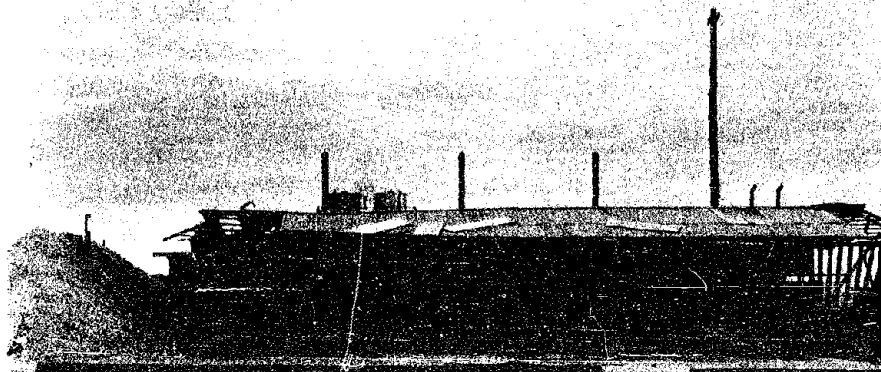
Fig. 3.21 Scientific Power House, Tare Island, Postshot,  
14-3/4 Miles from GZ

Figures 3.20 and 3.21 are pre- and postshot views of the scientific generator station looking east. Some of the rafters were broken, some sheet metal was ripped off the roof, and most of the plywood siding on the end of the building away from ground zero was blown off. Figure 3.22 is the end of this same building facing away from ground zero.

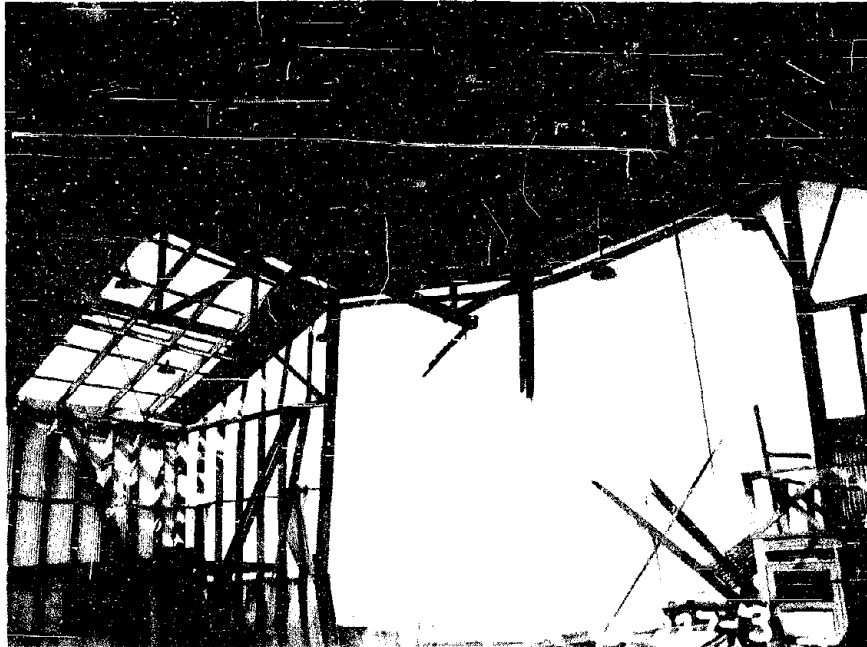
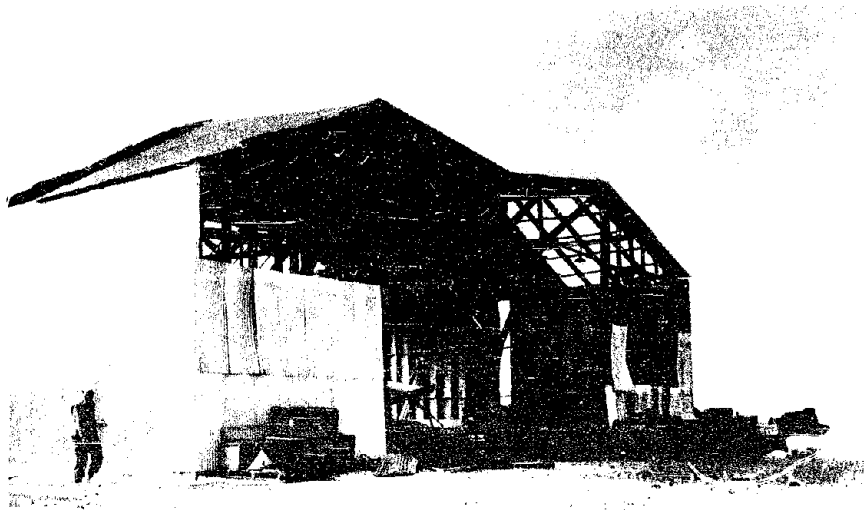
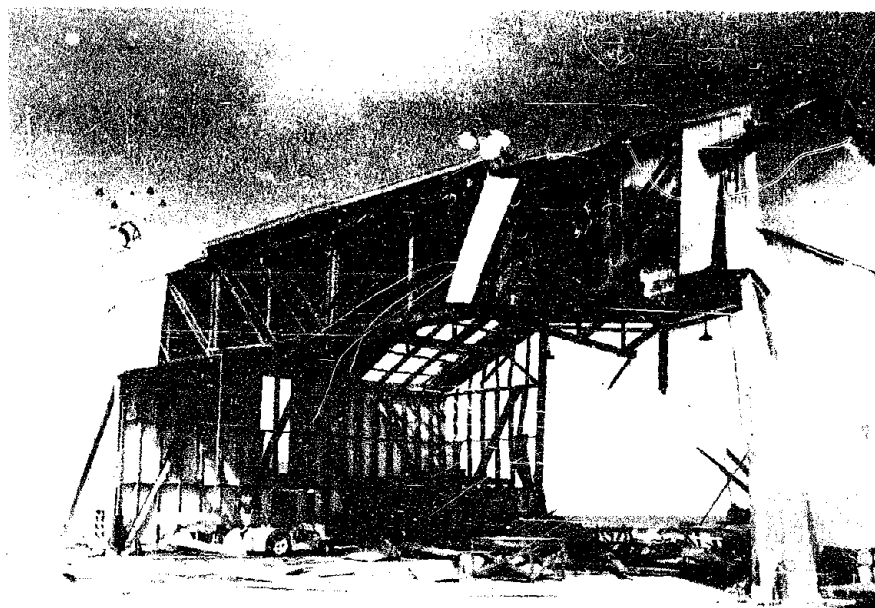
This structure suffered moderate to severe damage. The northwest (back) end of the hangar, including the 75-foot truss, had been almost completely blown out. This is best illustrated in Figs. 3.32 - 3.35. The lower chord of the 75-foot truss on the southeast (front) end was deflected outward several inches at the center of the span. Also, a considerable number of the 2" x 10" rafters were broken by the blast.

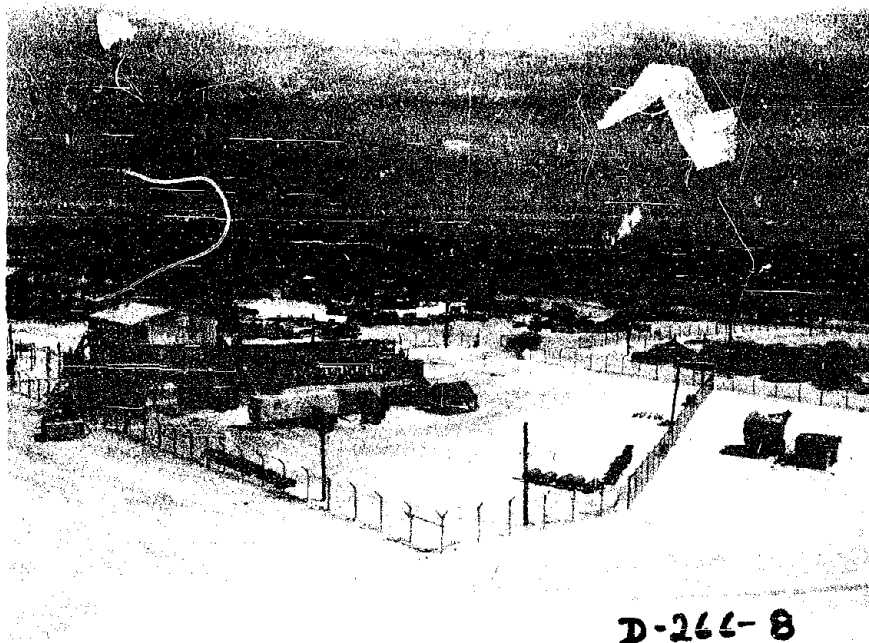
The steel photographic tower received no damage from the blast. The aluminum sheet metal siding on the steel frame building (Station 50) was dished inward on the west end and blown off on the east end. Figures 3.36 - 3.38 illustrate this damage. The sheet metal had been removed from the north side prior to shot time for Shot 1.

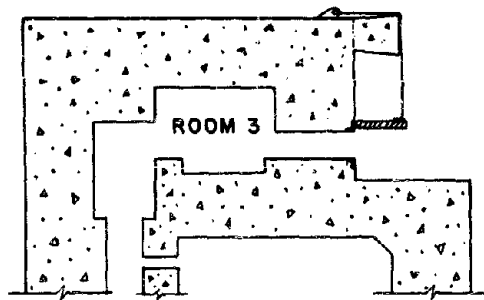
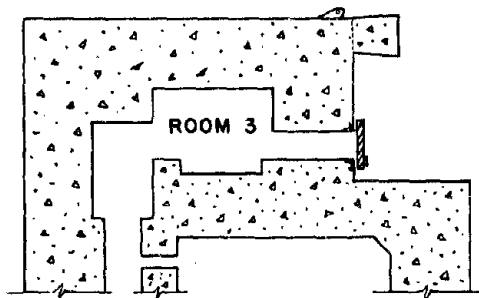
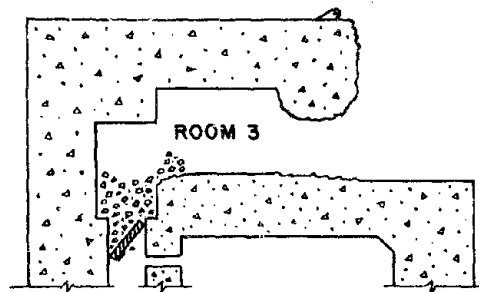
Fig. 3.42 Position of Shutter Door, Station 1341, Able Island,  
7500 ft from GZ

Due to the failure of the wall supporting the shutter door, the blast wave entered the building. The shutter door was hurled inward and dropped part way down the chimney, lodging in a position No. 3 as shown in Fig. 3.42. The forces from the blast also broke the latches and hinges from three other doors, namely, the lead door entering the equipment room on the first floor, the light weight steel door between rooms No. 1 and No. 4 on the first floor, and the main personnel door on the second floor. This door is shown in Fig. 3.45. The following doors did not fail: two exterior lead doors on the side of room No. 4, and three steel doors on the outside of the back wall of the equipment room.

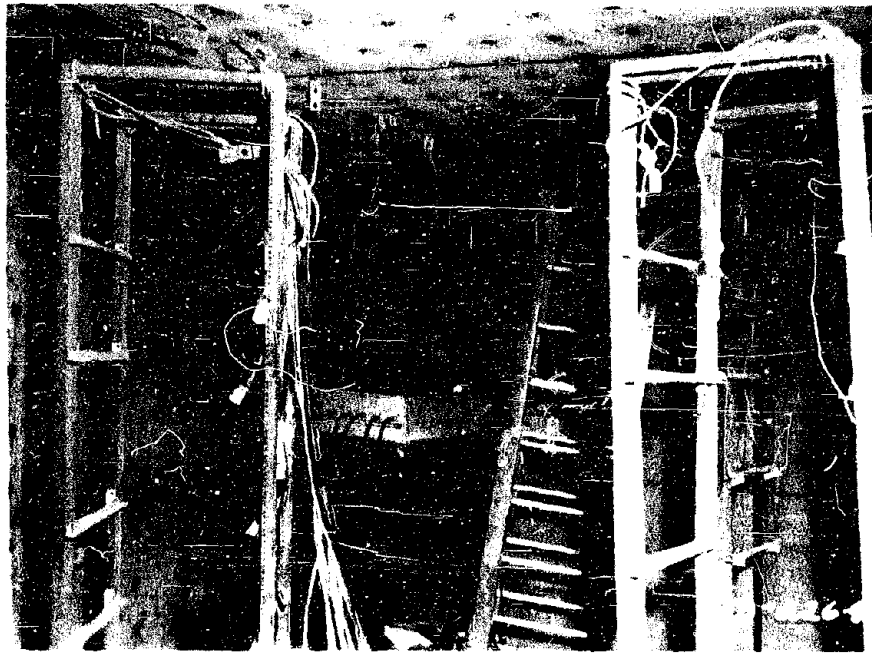
Fig. 3.48 Interior I - Room No. 3, Station 1341, Able Island, Postshot, 7500 ft from GZ

(3) The scientific equipment, equipment racks, and other interior structures were severely damaged. This damage can be noted in Figs. 3.48 and 3.51.
